TECHNICAL REPORT ARCCB-TR-02016

CHARACTERIZATION OF EXPLOSIVELY BONDED AND FIRED TANTALUM LINERS APPLIED TO 25-MM GUN TUBES

NOVEMBER 2002

US ARMY ARMAMENT RESEARCH,
DEVELOPMENT AND ENGINEERING CENTER
Close Combat Armaments Center
Benét Laboratories
Watervliet, NY 12189-4000

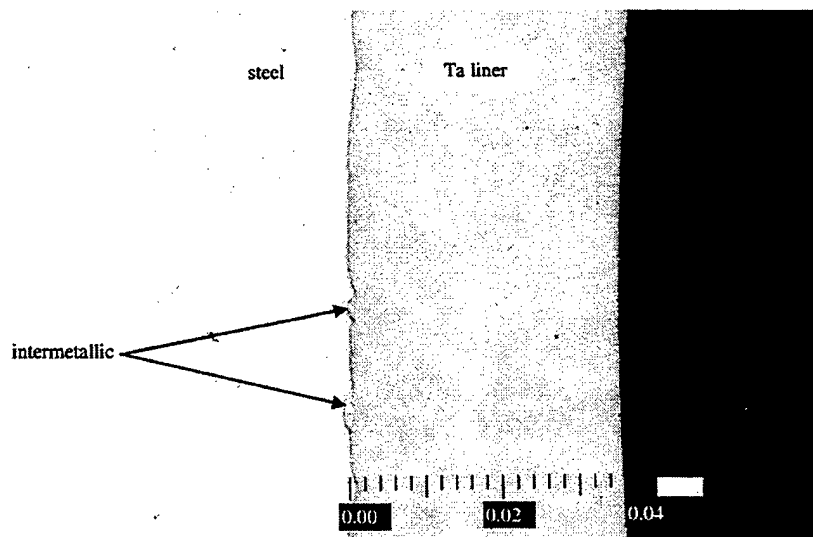
Figure 13. Metallurgical features of Tube A at 50X.

Metallographic examination of the unfired specimen revealed a fully dense, defect-free liner material (Figure 13). Along much of the steel/tantalum interface there appeared a hard, brittle intermetallic at all locations. The waveform of the interface is illustrated in Figure 14.

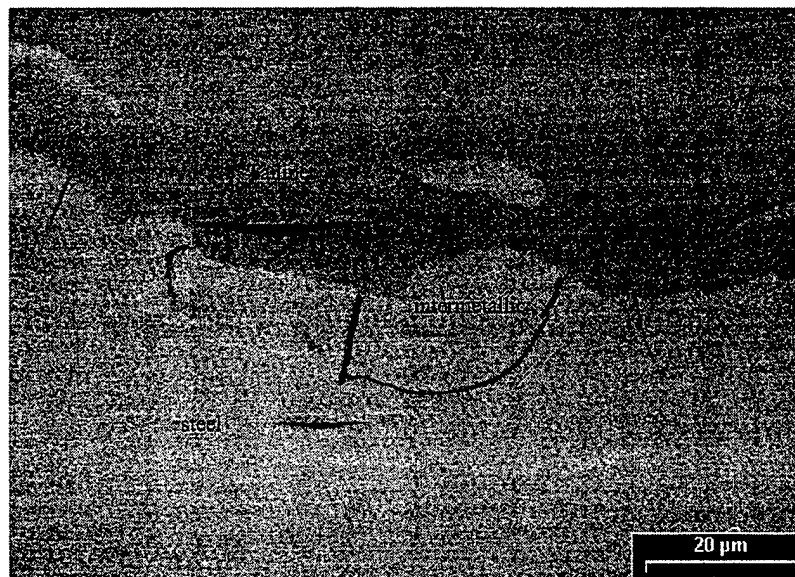
Figure 15. Tube B hardness variations of steel, liner, and intermetallic.

The liner of Tube B exhibited the same bulk features as Tube A. The liner was dense and defect-free and along much of the interface, a brittle and cracked intermetallic was present. The microhardness of the intermetallic in this tube was also $\sim\text{HK}_{50}$ 900. An image illustrating the comparative hardness values of the steel, intermetallic, and tantalum liner is given in Figure 15. Besides minor plastic deformation, the steel microstructure appeared relatively unaffected by the explosive bonding process. The one location examined in which the microstructure of the steel was noticeably altered occurred at the 8-inch location (Figure 16b). Although the microstructure is altered, there is no significant hardening or softening of the steel, so the ramifications of this insofar as fatigue life is concerned are unknown.

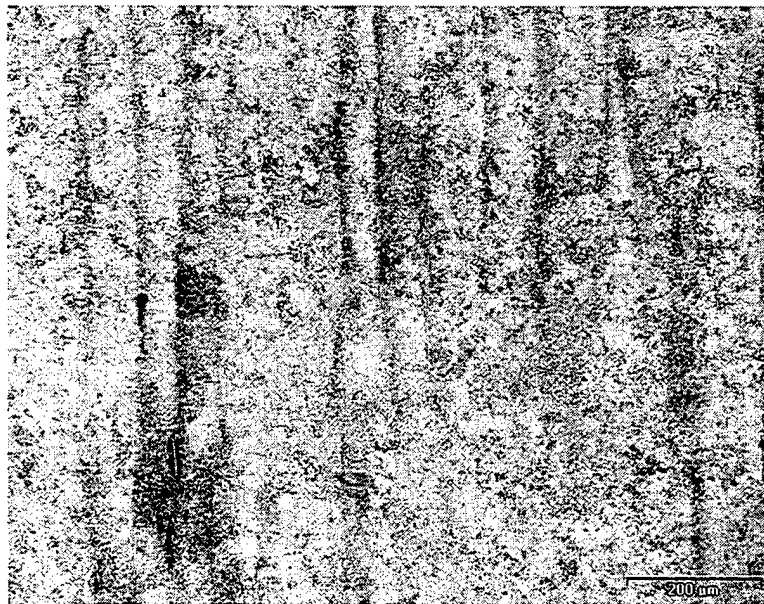
Etching revealed banding parallel to the tube axis throughout the steel substrate of Sample A, as shown in the cross-section of Figure 25. There are many occurrences of inclusions oriented along the bands. These features reflect the quality of material used for the manufacture of this gun tube.

Figure 25. Substrate steel of unfired explosively bonded tantalum-coated gun tube at magnification 200X. This cross-section is perpendicular to the bore and parallel to the tube axis.

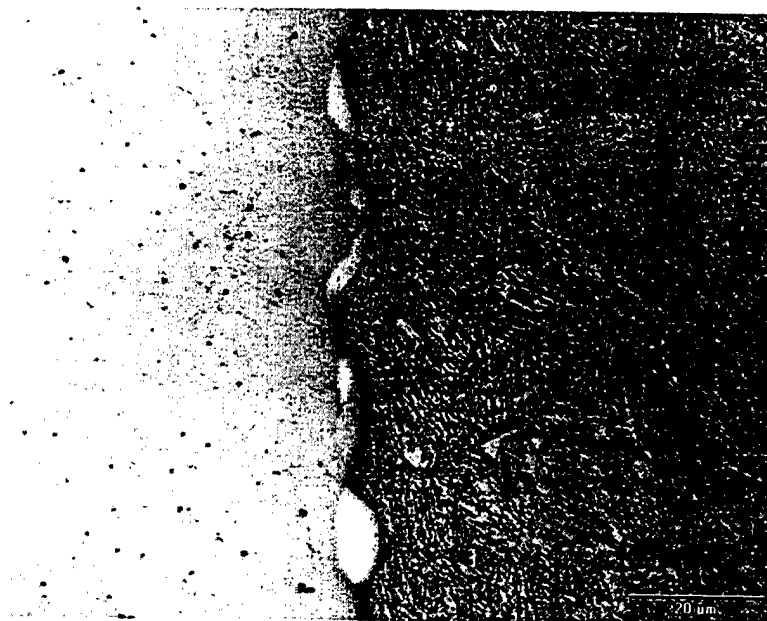
Also observed was the formation of an intermetallic phase found at random locations throughout the irregular explosively bonded tantalum/steel interface, as shown in Figure 26. As no heat-affected zone is seen adjacent to these regions, this intermetallic phase was produced without high heating. These results are consistent with the cold welding process attributed to explosive bonding.

Figure 26: Explosively bonded tantalum/steel interface of Sample A at magnification 2000X.

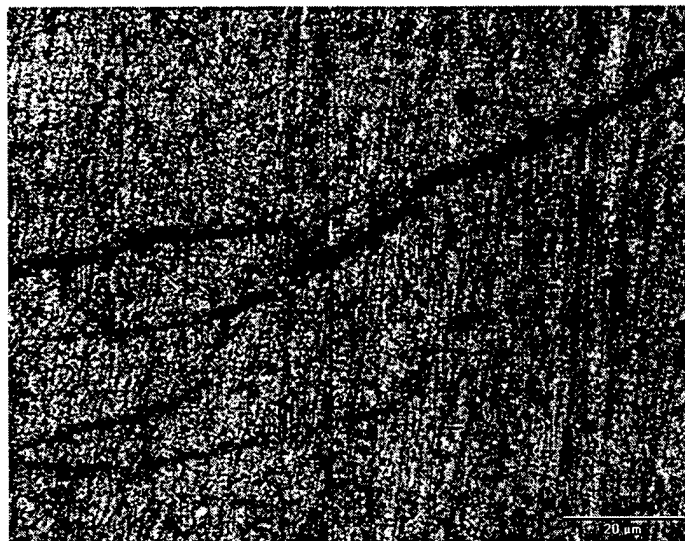
Figure 27. Laser pulsed region of unfired explosively bonded tantalum coating at magnification 2000X.

Staining throughout the pulsed region indicates that an oxide layer formed during heating. It was observed that there is a tendency for rapid oxidation of the explosively bonded tantalum during pulsing in air at ambient conditions. The surface cracks shown here are representative of those found throughout spot 1, with widths ranging from approximately 0.5 to 3.0 μm .

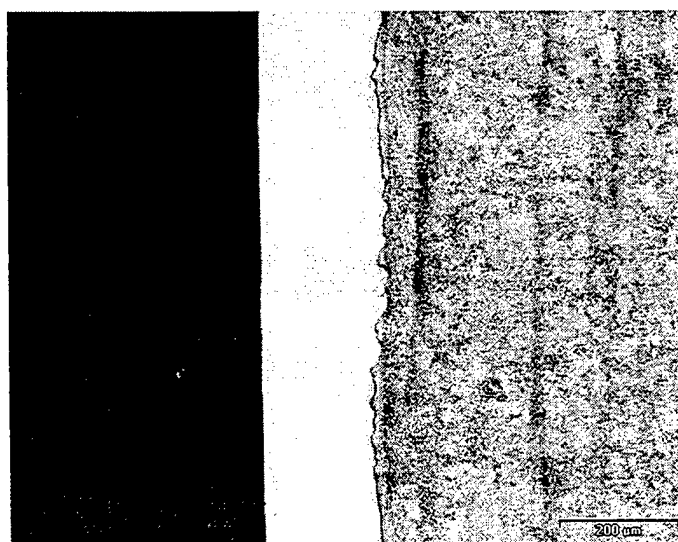
Figure 28 shows the cross-section of spot 1 taken at a magnification 200X. This image illustrates cracking of the brittle intermetallic phase, along with the formation of a small heat-affected zone in the steel adjacent to the interface. Coating thickness is approximately 210 μm within the pulsed region.

Figure 28. Laser pulsed spot 1 at magnification 200X.

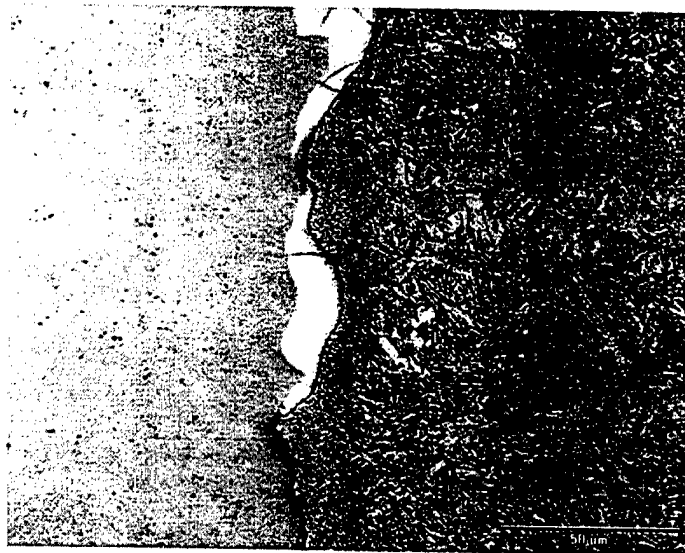
While fine cracking of the intermetallic phase was seen throughout some locations along the interface, larger cracks were found in the intermetallic phase within the laser pulsed regions. Figure 29 shows the interface of spot 1 at increased magnification.

Figure 29. Effects of laser pulsing spot 1 at magnification 1200X.

Here the heat-affected zone is seen to extend approximately 8 to 15 μm into the steel substrate. It is nonuniform, and appears along the waveform where the steel rises higher into the coating. Figure 30 shows a 2- to 3- μm thick oxide layer that has formed on the tantalum surface. Within the cross-sections of the laser-heated spots, no surface cracks have progressed through the oxide layer, suggesting that the explosively bonded tantalum is resistant to crack propagation from thermal shock.

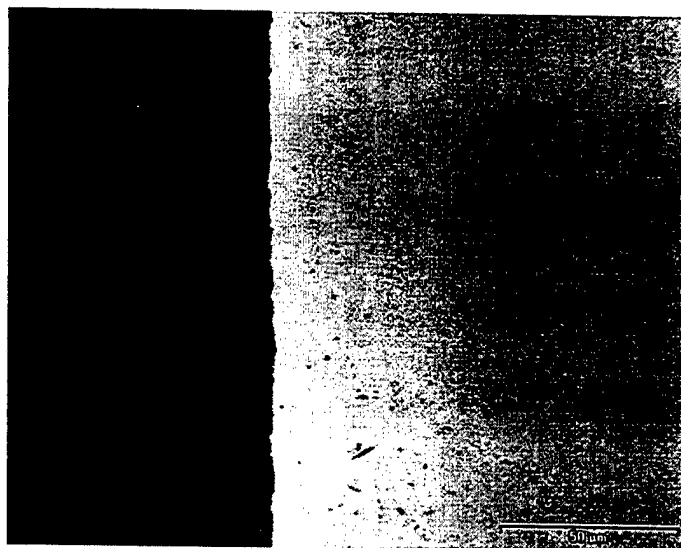
Figure 30. Surface oxide layer from laser pulsing spot 1 at magnification 2000X.

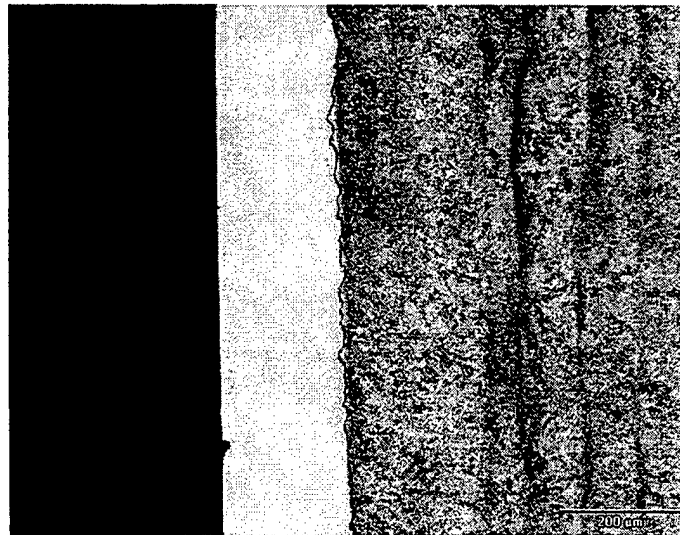
Figure 32. Laser pulsed spot 2 at magnification 200X.

Figure 32 also illustrates once again, the highly irregular interface with small regions of intermetallic phase present. A heat-affected zone is also seen in the steel adjacent to the interface. Coating thickness is approximately 210 μm within the pulsed region. Figure 33 shows this interface at increased magnification.

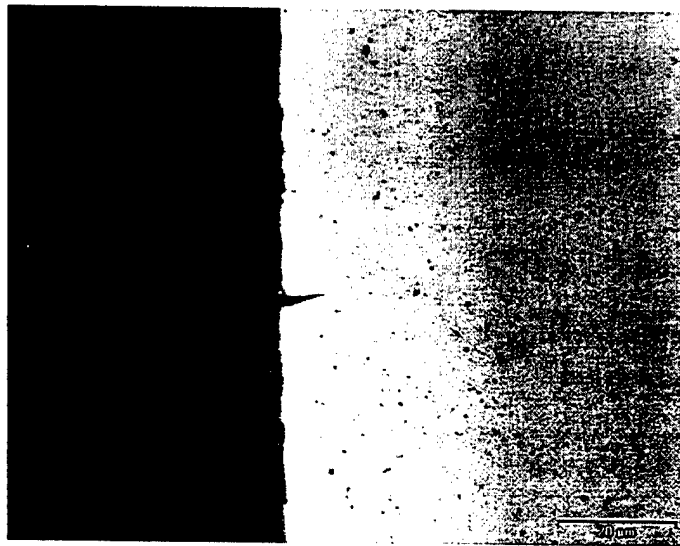
Here the heat-affected zone is seen to extend approximately 8 to 10 μm into the steel substrate. It is nonuniform and appears where the steel rises higher into the coating. Figure 34 shows a 2- to 3- μm thick oxide layer that has formed on the tantalum surface. Within the region shown, one surface crack has progressed through the oxide layer.

Figure 34. Surface oxide layer from laser pulsing spot 2 at magnification 2000X.

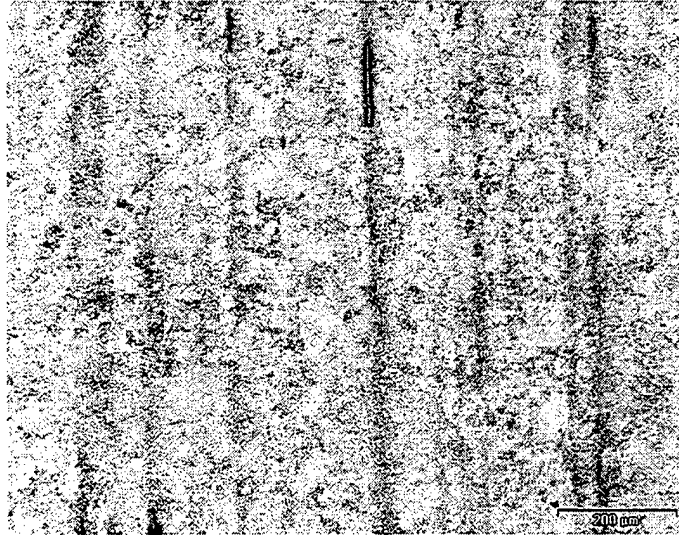
Similar to the unfired specimen, etching revealed banding parallel to the tube axis and inclusions throughout the steel substrate of Sample B, as shown in the cross-section of Figure 35.

Figure 35. Substrate steel of fired explosively bonded tantalum-coated gun tube at magnification 200X. This cross-section is perpendicular to the bore and parallel to the tube axis.

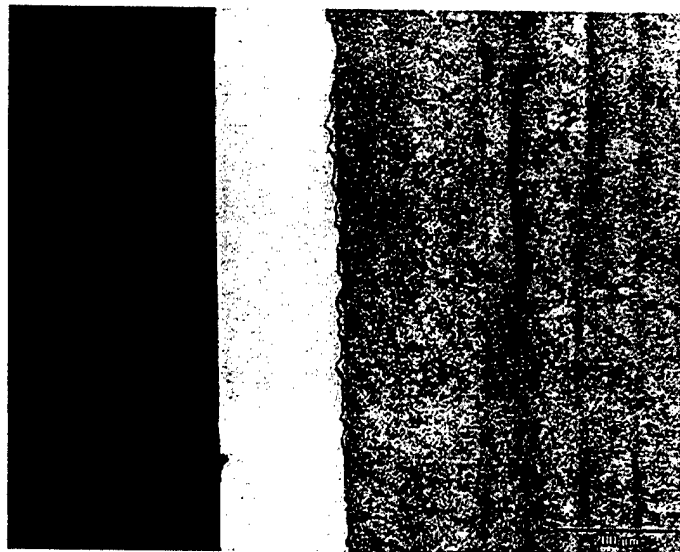
Figure 37. Laser pulsed spot 1 at magnification 200X.

Figure 37 also shows the formation of a heat-affected zone adjacent to the irregular explosively bonded tantalum/steel interface. Coating thickness is approximately 190 μm . Figure 38 shows the interface at increased magnification. Here the heat-affected zone is seen to be fairly uniform, and extends approximately 10 to 15 μm into the steel substrate.

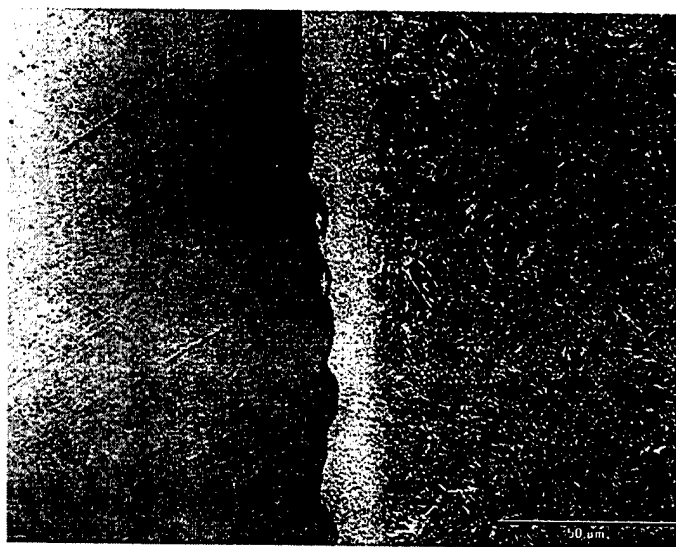
Figure 38. Effects of laser pulsing spot 1 at magnification 1200X.

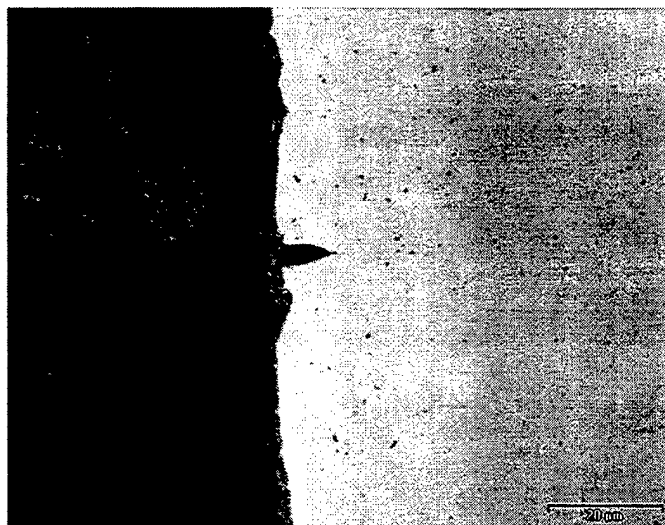
Figure 39 shows a 2- to 3- μm thick oxide layer that has formed at the tantalum surface. Here a surface crack is shown that has progressed through the oxide layer into the explosively bonded tantalum, and has propagated about 9 μm into the coating.

Figure 39. Surface oxide layer from laser pulsing spot 1 at magnification 2000X.

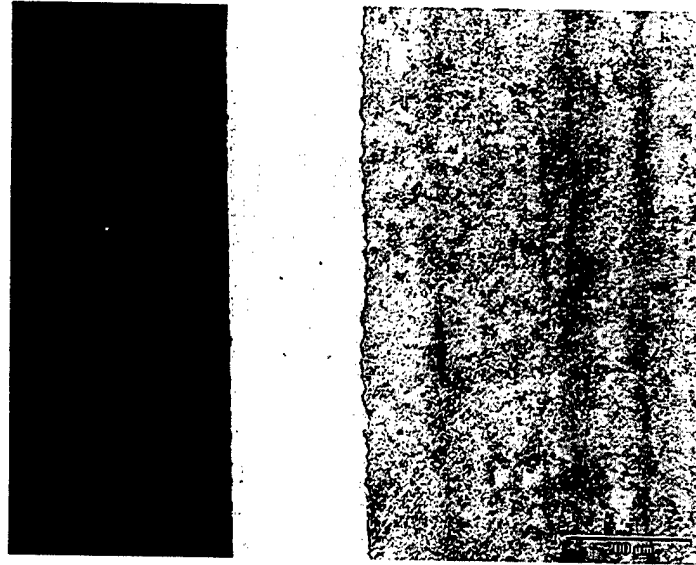
Figure 41 shows minimal formation of a heat-affected zone in the steel adjacent to the interface. This is attributed to both the lower pulse energy used at this location and an increased thickness of the explosively bonded coating as compared to spot 1. Here the average coating thickness is 230 μm .

Figure 41: Cross-section of spot 2 taken at magnification 200X.

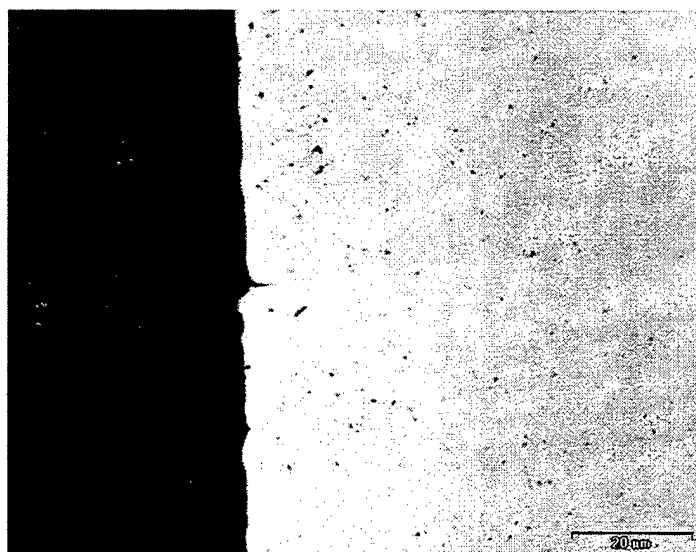
Figure 43 shows a 2- to 3- μm thick oxide layer that has formed at the tantalum surface. Within this region, one surface crack has progressed through the oxide layer.

Figure 43. Surface oxide layer from laser pulsing spot 2 at magnification 2000X.
